# Puffin pedestrian crossing accident study

**PUBLISHED PROJECT REPORT PPR507**

**Prepared for: Project Record: PPRO 04/16/18**  
**Puffin Pedestrian Crossing Accident Study**  
**Client: The Department for Transport, Traffic Management Division**  
**(Suku Phull)**

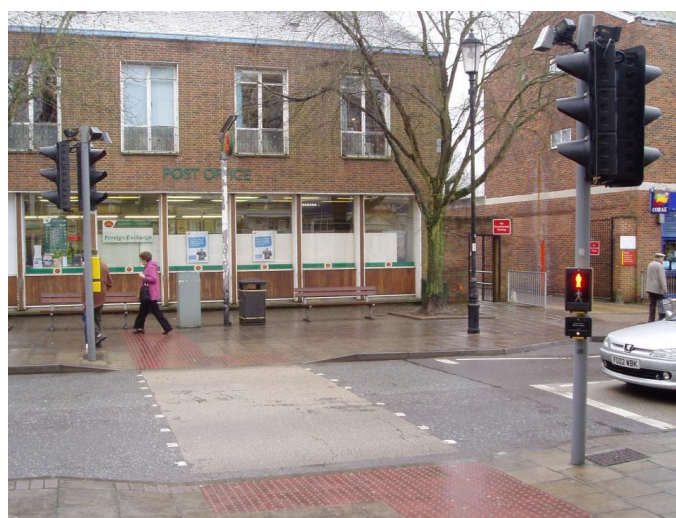
**Figure 2.1: Example of a mid-block Puffin crossing**

Puffin facilities were devised to replace existing farside facilities. Figure 2.1 shows a typical Puffin crossing. The main differences between Puffin facilities and existing farside facilities are:

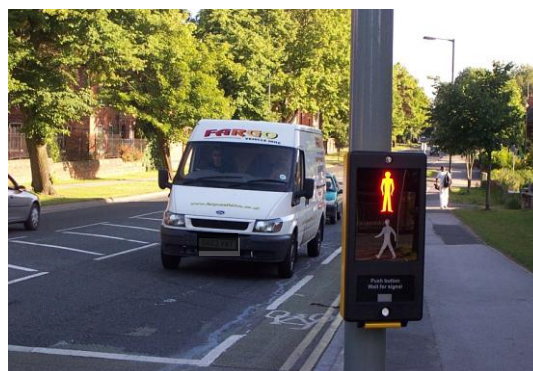
**Figure 5.1: Pedestrian view of nearside signals, showing on-coming traffic in line of sight**

Nearside pedestrian signals should increase pedestrian awareness of on-coming traffic. Pedestrian 'failed to look properly' is the largest single factor in pedestrian accidents at signal crossings (Table 5.2). Nearside signals are located so that waiting pedestrians looking at the pedestrian signals also have approaching traffic in their line of sight (Figure 5.1). Pedestrian observation of traffic while on the crossing should also increase due to no visible pedestrian signals once on the crossing.

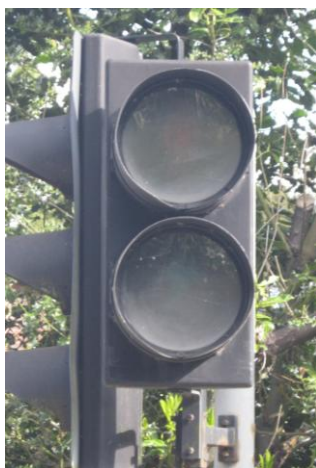
**Figure 5.2: 'Blackout' at a farside pedestrian signal**

A recent large survey by TRL for Transport for London (Sterling *et al*, 2009) found significant confusion over the meaning of the blackout period, with 60% of pedestrians either not knowing or giving an incorrect answer. Results of a large video survey over a number of junctions indicated that virtually all pedestrians arriving in the blackout period choose to cross, 10% of all pedestrians started to cross in this period and the blackout period averaged 10% of the cycle-time. Figure 5.2 shows the farside pedestrian signal 'blackout' at a junction.

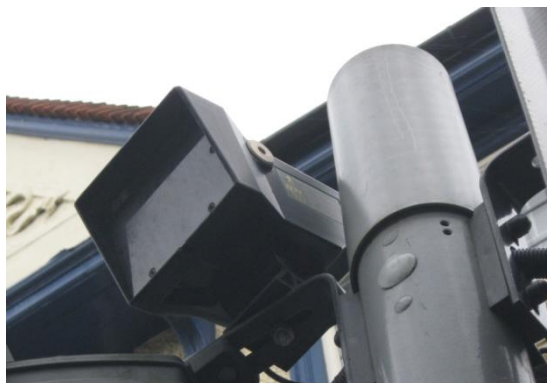
**Figure 5.3: On-crossing detection unit**

Various authors (e.g. Gates *et al* (2006), Fitzpatrick *et al* (2005), Baass (1989), and Wall (2000)) have pointed out that the ageing population will ideally require signal timings to be based on a slower walking speed than the 1.2m/sec currently used. On-crossing detectors allow the clearance period to be increased as required, thus potentially bringing safety benefits and catering for pedestrians with impaired mobility without a wholesale increase in clearance periods, leading to increases in road-user delay and cycle-time. Figure 5.3 shows an on-crossing detection unit.

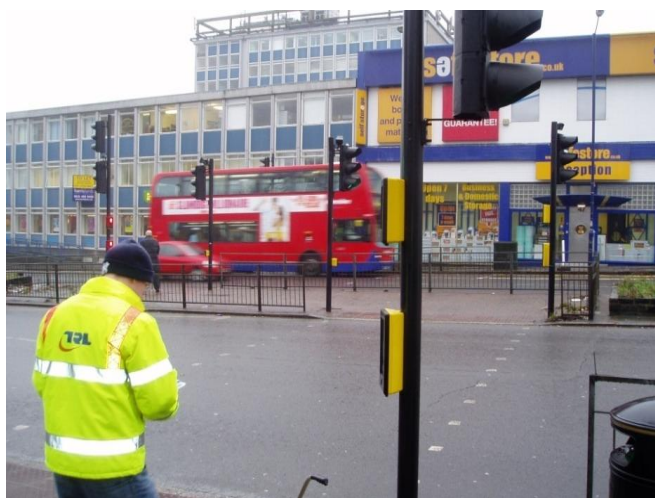
Figure 6.1 shows a site inspection in progress. Sites were classified according to the data collected on site. The following categories were used:

Figure 6.1: Site inspection
