# Advanced zinc-based hot dip coatings for the automotive application (AUTOCOAT)

# Research Fund for Coal and Steel

Grant Agreement RFSR-CT-2009-00014  
1 September 2009 to 28 February 2013

### Final report

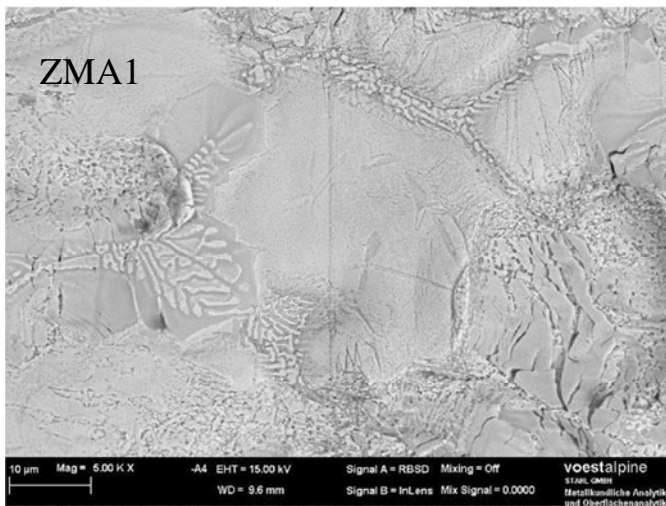
**Figure 3: BSE images of the surfaces of the production line coatings.**

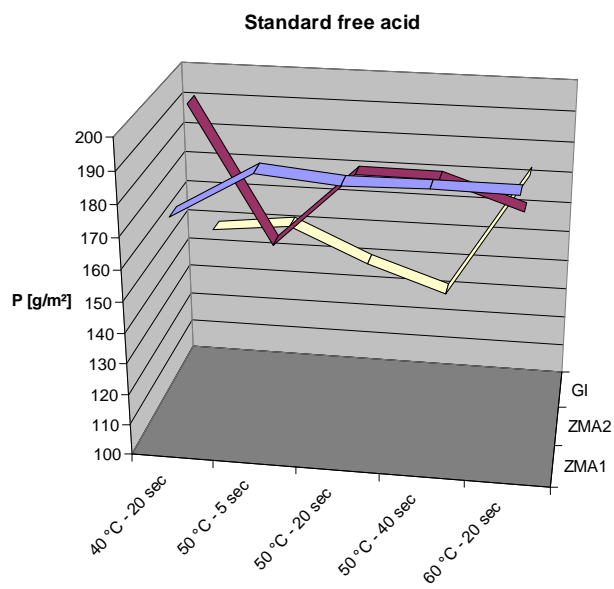
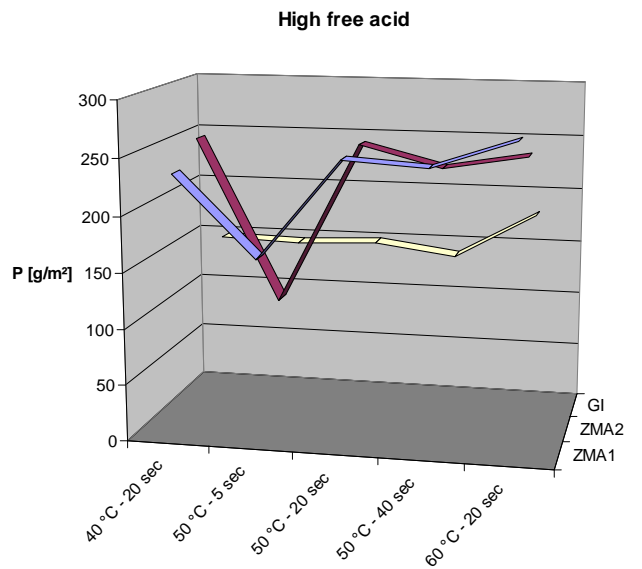
**Figure 19: Phosphor deposition on different line hot dip coated steel (GI, ZMA1, ZMA2) as a function of temperature, time and free acid conditions.**

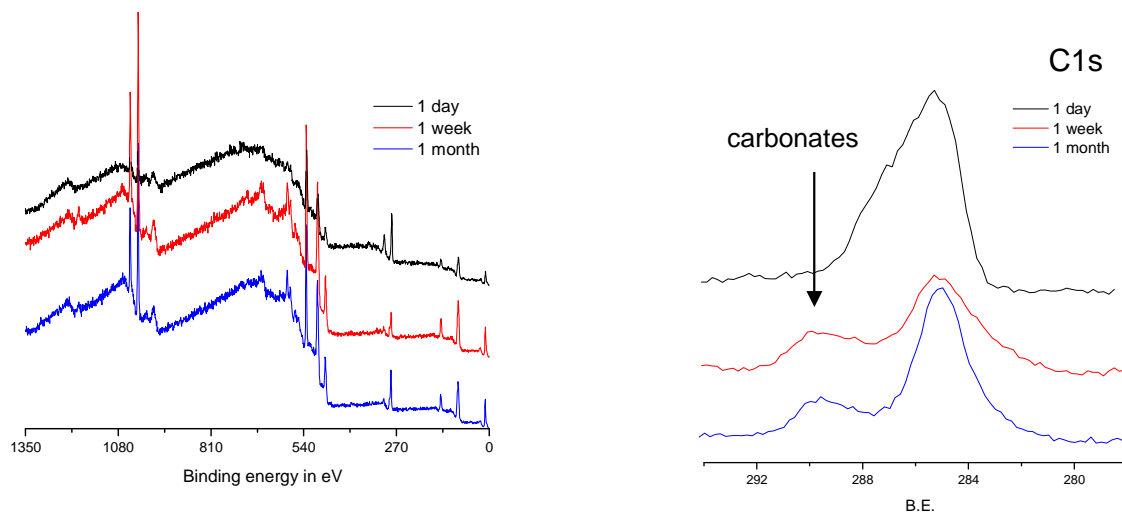
**Figure 26: Survey and C1s detail spectra of the ZMA2 cast sample exposed to an marine atmosphere, as function of exposure time (as indicated).**

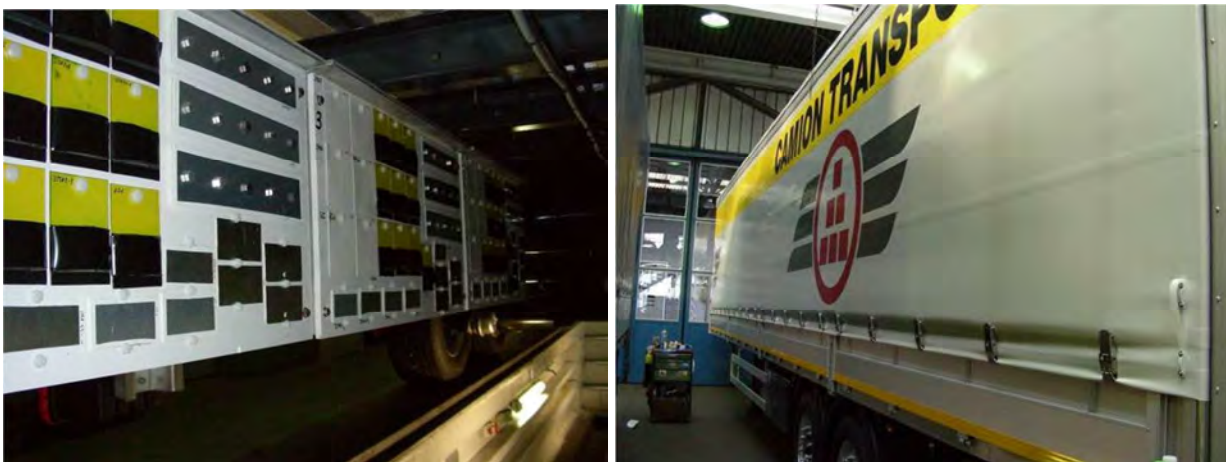
Truck exposure - The samples have been exposed under a trailer of a truck driving in the Swiss Alps around Zürich area on October 22, 2010, see photograph on Figure 38. Due to space restriction under the trailer, the number of samples has been limited. Thus, only one reference line hot dip coating was exposed e.g. GI, and 2 replicates per exposure duration and materials. One set of samples was removed after 1 year and a second one after two years. In addition to Autocoat samples, CRS and pure zinc panels were exposed to measure the yearly metal loss, which results are given in Table 12. Despite such results are highly dependent on many parameters (driving location and conditions, distance, service of the truck, garage parking), the data are typical for roads with moderate use of de-icing salts [7].

Figure 38: Photographs of the samples exposed under the trailer

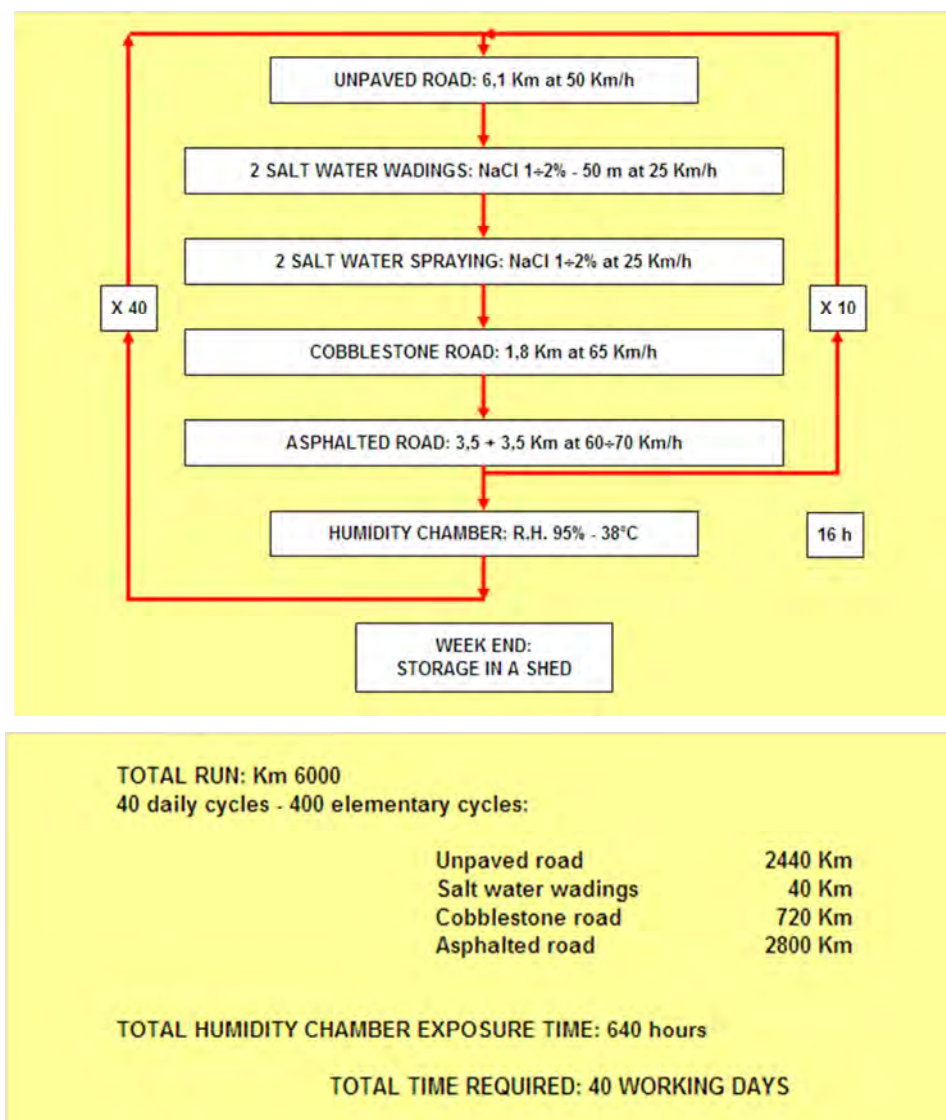
**Figure 39: Main characteristics of FIAT proving ground**

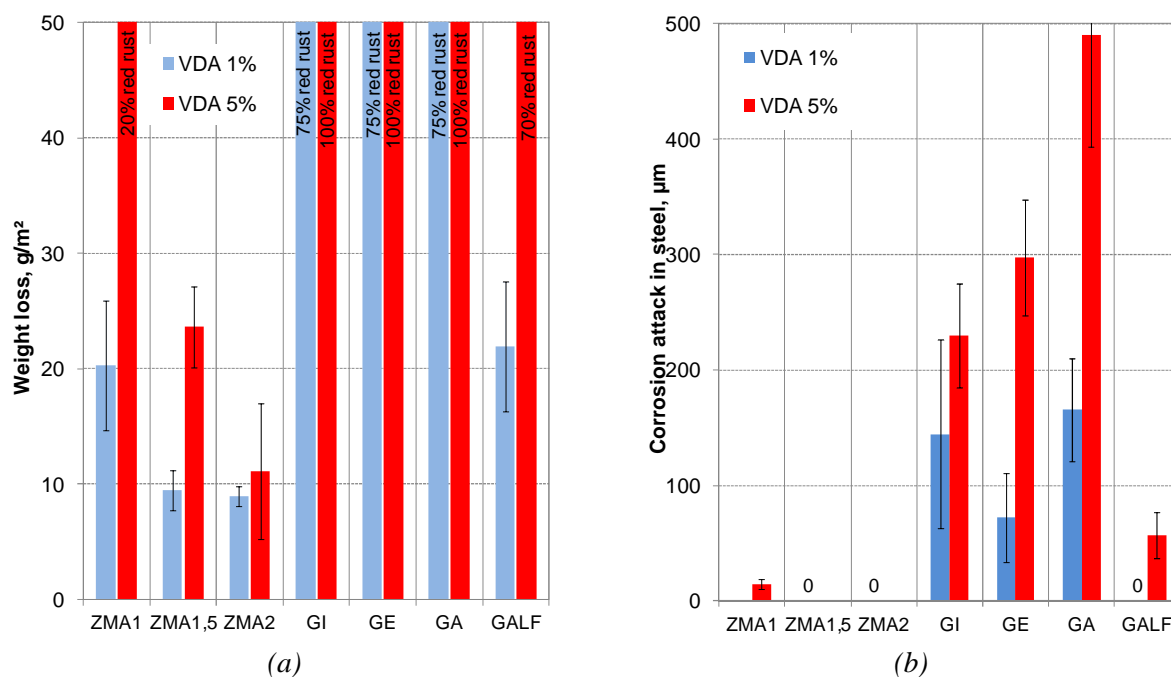
**Figure 70: Influence of NaCl concentration (NaCl 5 and 1wt%) in VDA 621-415 cycle on the corrosion of metallic coatings in open configuration. (a): weight loss and (b): maximal depth of corrosion in steel after 12 weeks of test.**

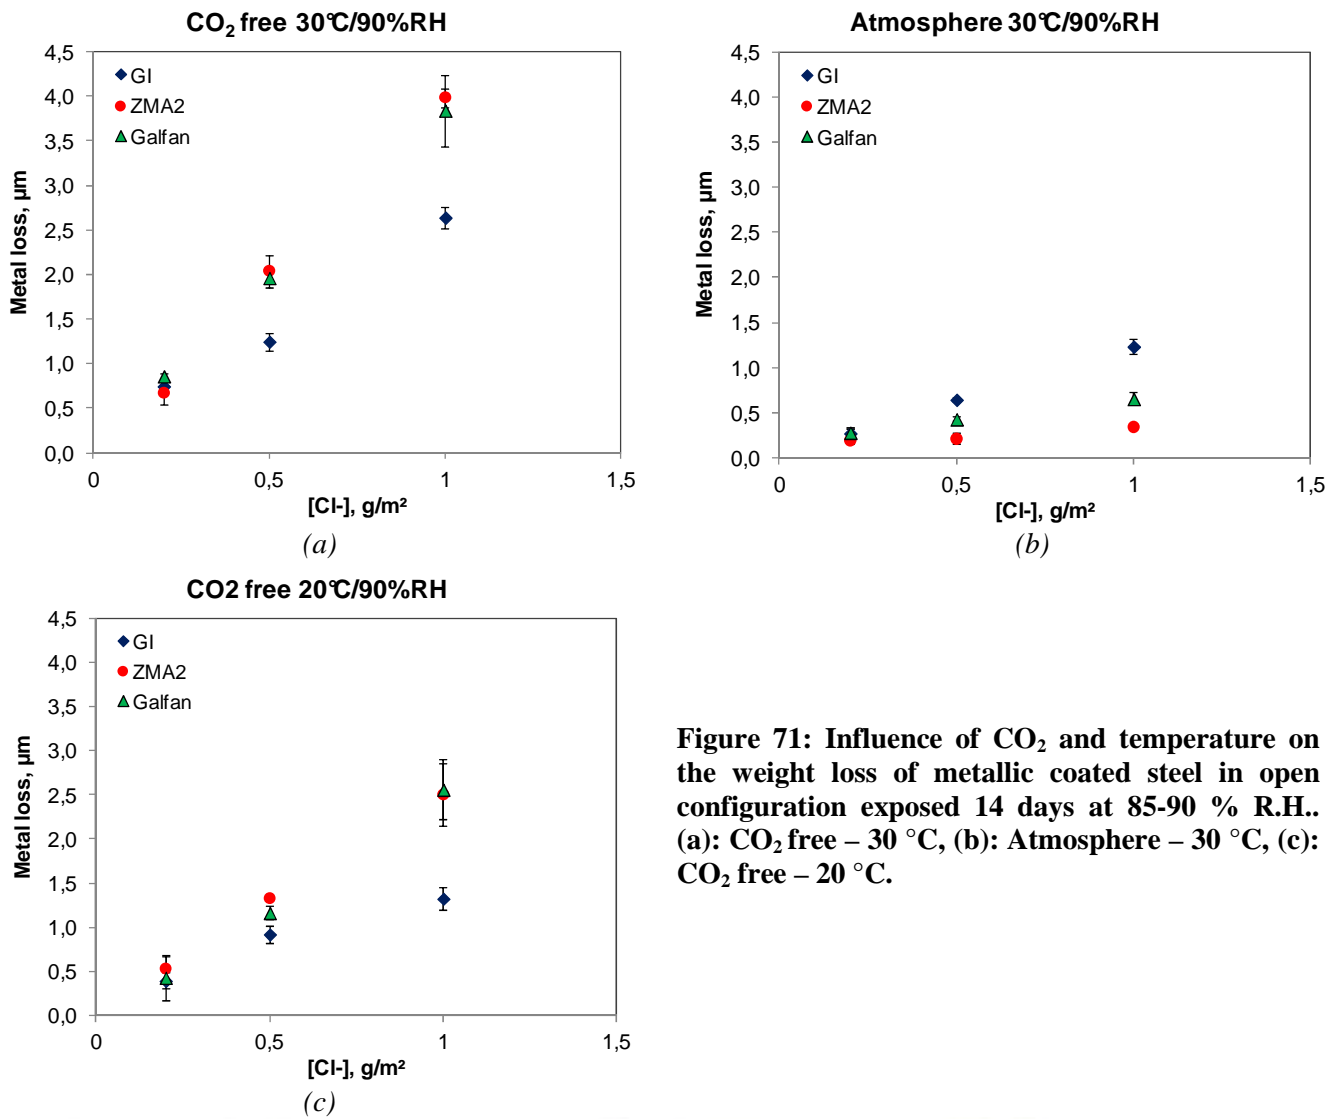
**Figure 71: Influence of CO<sub>2</sub> and temperature on the weight loss of metallic coated steel in open configuration exposed 14 days at 85-90 % R.H.. (a): CO<sub>2</sub> free – 30 °C, (b): Atmosphere – 30 °C, (c): CO<sub>2</sub> free – 20 °C.**
